# PERFORMANCE REPORT

**ARL Lab Number:**  
**50175**

**Test Method:**  
**Miami-Dade County Protocol TAS 114, Appendix E (1995)**

**Product:**  
**Dryer Vent**

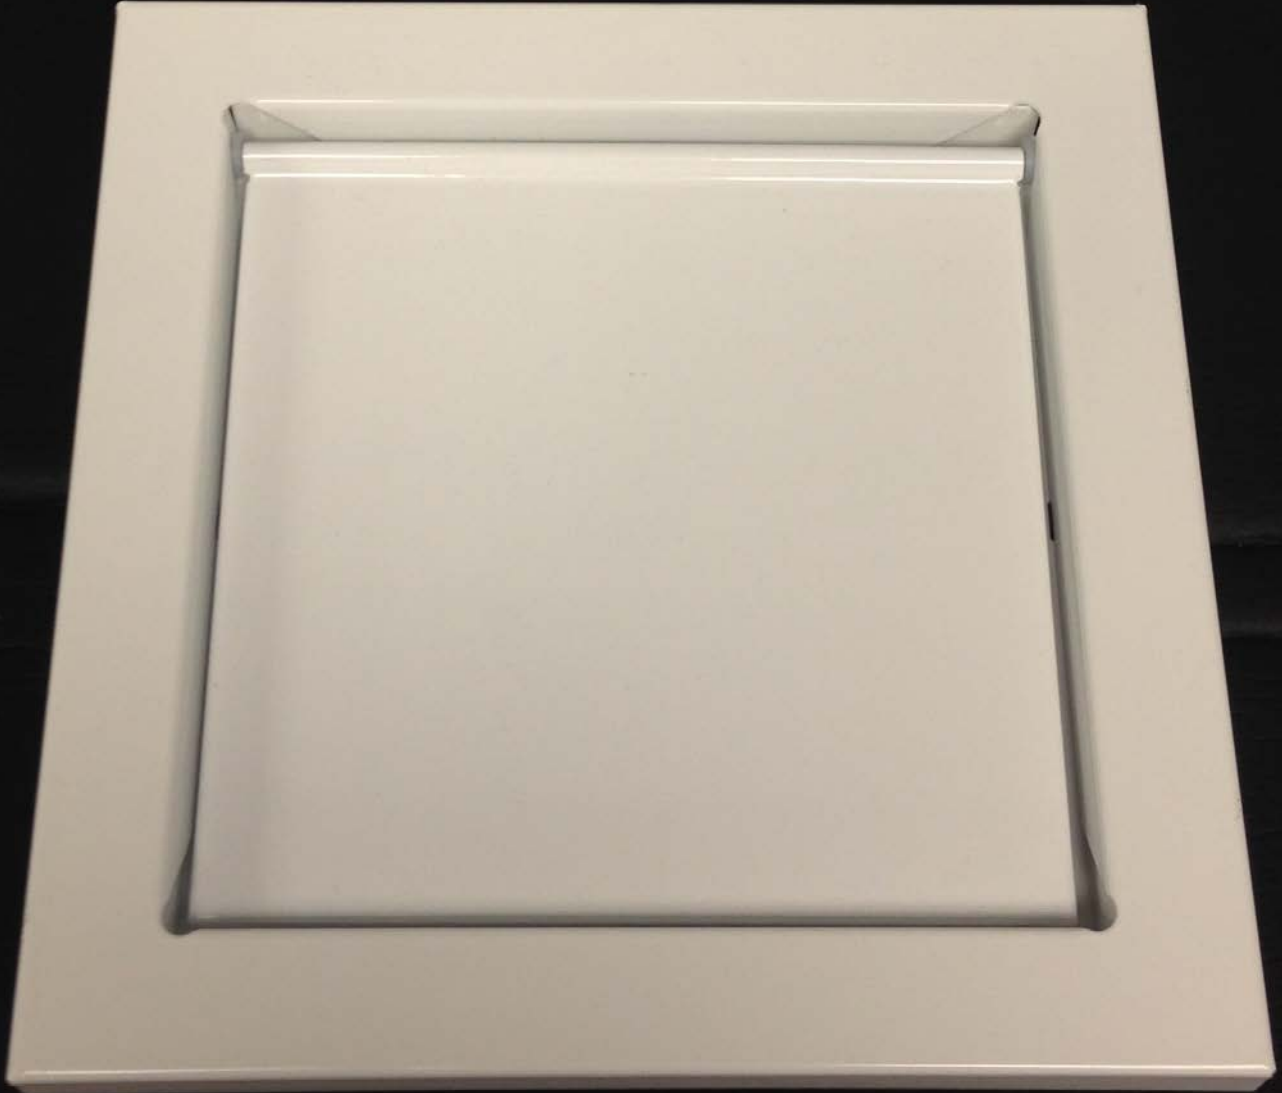
**Photograph 1  
Before**

2.4 Photographs of the untested specimen are shown below.

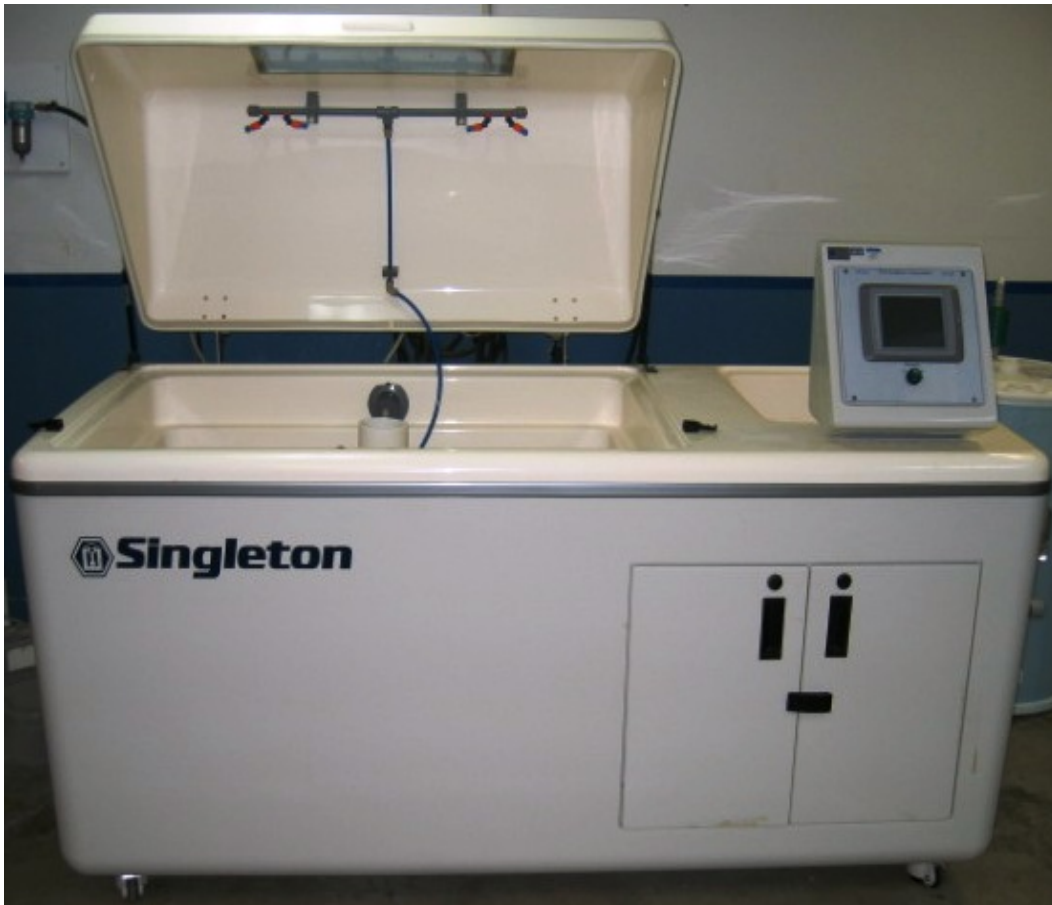
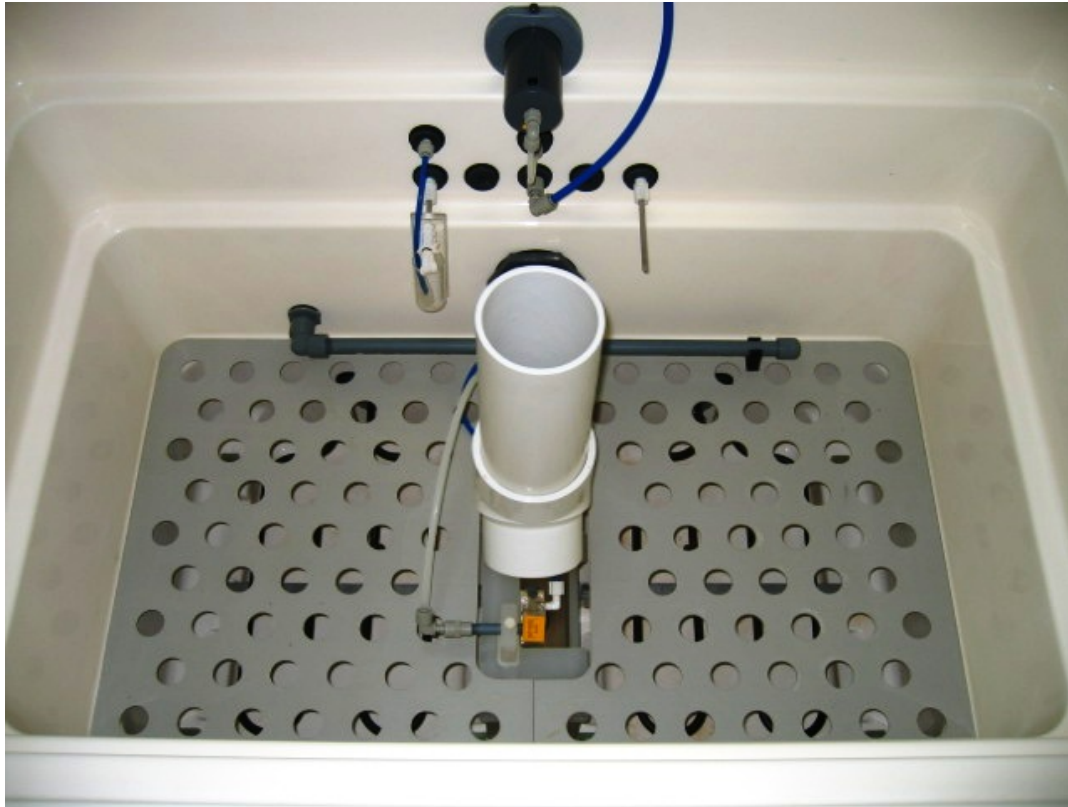
**Photograph 5**  
**Cyclic Corrosion Test Chamber**

- 3.1 Cyclic Corrosion Test Chamber – The ARL Cyclic Corrosion Test Chamber was utilized to accommodate the parameters of TAS 114, Appendix E, for the purpose of testing the dryer vent. The Chamber, Model CCT10-MB-8AD, was manufactured by Singleton Corporation. The sample space volume is 21 ft<sup>3</sup>. The inside dimensions are 48 x 33 x 24 inches. The Chamber has a temperature range of ambient - 140°F and a humidity range of ambient - 100%.

- 3.3 For the spray cycle, the temperature inside the chamber was maintained at  $75 \pm 6^{\circ}\text{F}$ . The fogging was achieved by using a single nozzle connected to an air supply. The solution was drawn out of the main reservoir to a secondary reservoir inside the sample space and then atomized by the nozzle and released into the chamber, thus exposing the dryer vent to the salt fog.

- 3.4 During the drying cycle, the temperature inside the chamber was maintained at  $95 \pm 3^{\circ}\text{F}$ . The Chamber is capable of reaching the required temperature within 45 minutes as required by TAS 114, Appendix E. The drying was aided by evacuating the chamber of all sprayed solution and then beginning the heating process. The evacuation lasts approximately 5 minutes. All visible moisture was removed from the samples. Heating is accomplished by two (2) heater elements located in the bottom of the Chamber.
